DREDGING OF CAÑO MARTÍN PEÑA
PUERTO RICO
FINAL
PROJECT DESIGN REPORT AND
ENVIRONMENTAL IMPACT STATEMENT

This Project Design Report describes the study area's problems, formulates several dredging and disposal alternatives, and prepares a detailed design and draft environmental impact statement of the recommended project. The report was prepared under the U. S. Army Corps of Engineers Support for Others Program, at the request of the Puerto Rico Department of Natural and Environmental Resources.

The recommended project consists of dredging about 750,000 cubic yards of mixed material along the existing channel to provide a, 10 feet deep by 150 to 230 feet wide, rectangular channel delimited by a vertical steel sheet pile bulkhead system. The dredging would begin at the San José Lagoon and extend for about 11,600 feet to end west of the Luis Muñoz Rivera Avenue bridge. Most dredged material would be disposed at two of the largest deep holes located in Los Corozos and San José lagoons. A recreation walkway and four fishing piers would be installed on top of the channel walls along portions of the channel. Portions of the permanent right-of-way will be planted with mangroves. The proj

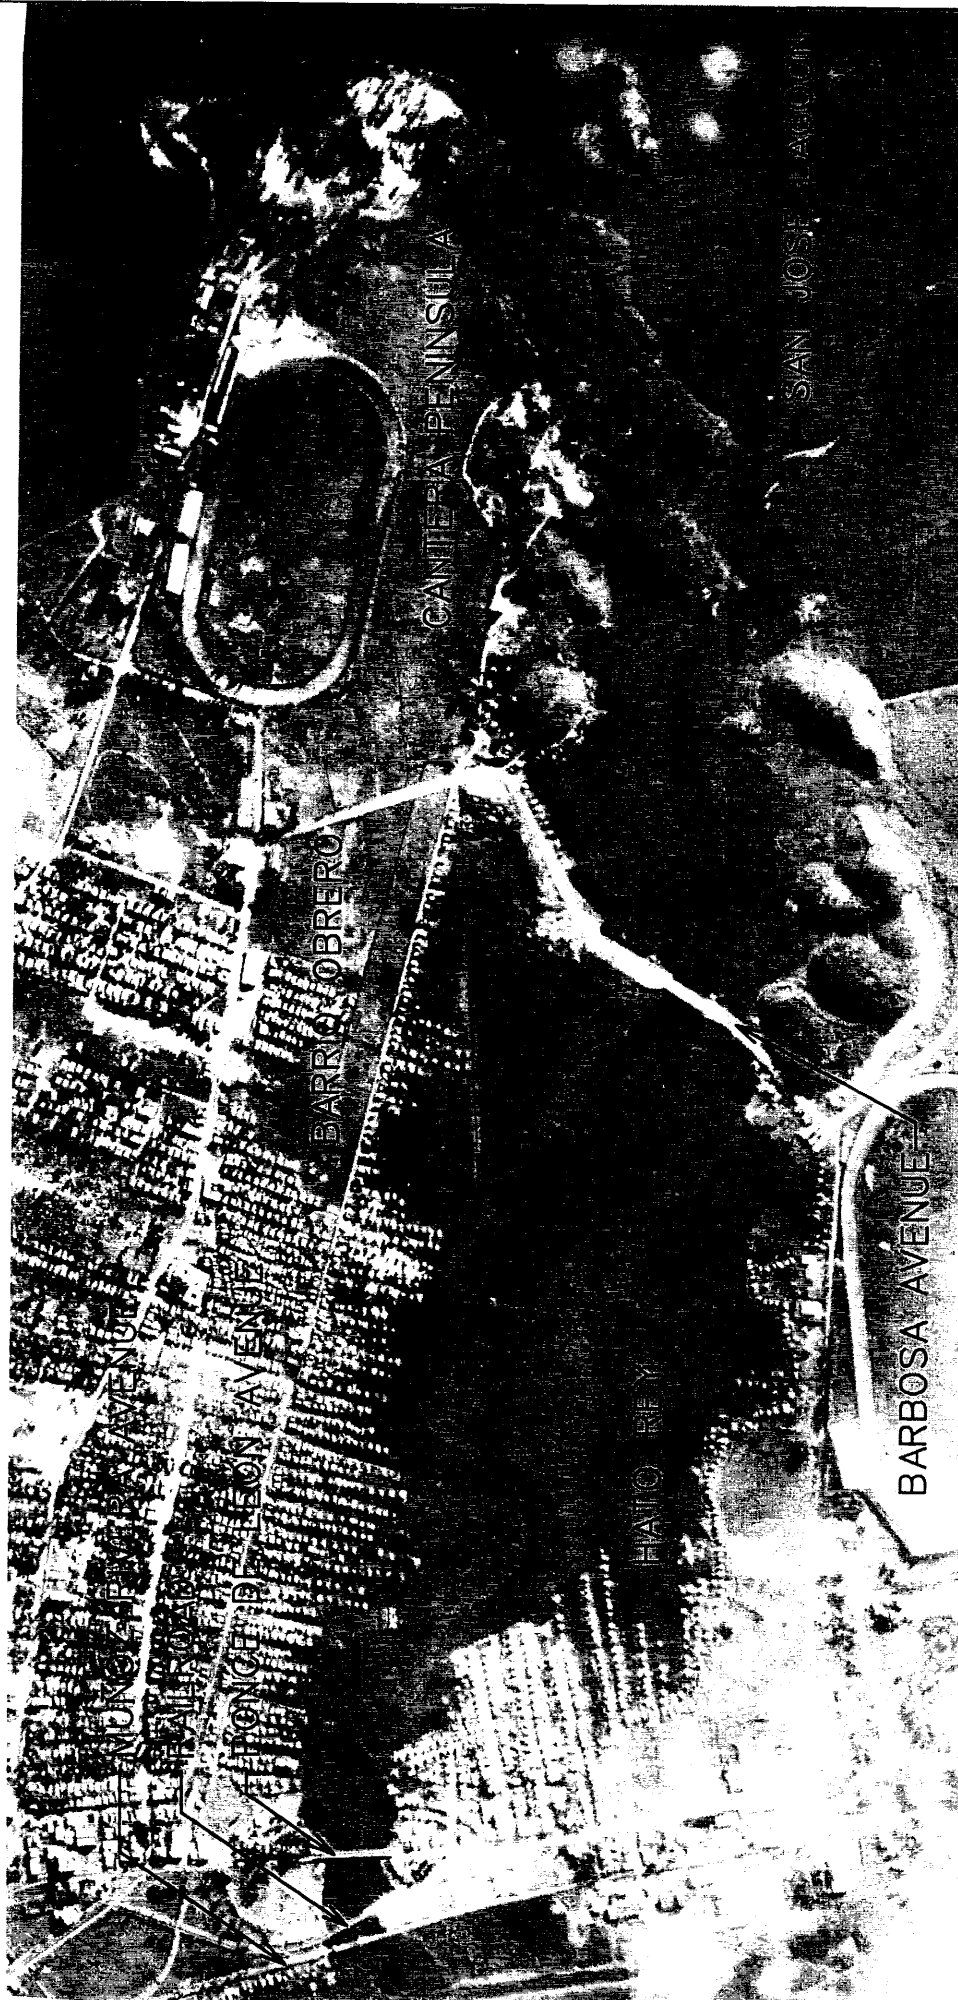
DEPARTMENT OF THE ARMY JACKSONVILLE DISTRICT, CORPS OF ENGINEERS JACKSONVILLE, FLORIDA	
PROJECT DESIGN REPORT CAÑO MARTIN PEÑA SAN JUAN, PUERTO RICO	
CAÑO MARTIN PEÑA 1936 AERIAL PHOTO	
INV. NO.	SIZE DRAWING NO.
DATED:	FIGURE 3
SCALE: AS SHOWN	DATED: 11-24-99
SHEET 1 OF 1

A 1936 aerial photograph of Caño Martín Peña between Muñoz Rivera Avenue and San José Lagoon, shows a natural channel from 200 to 400 feet wide with an extensive herbaceous wetland, no mangroves, and very limited urban development along its banks (see Figure 3). A 1951 aerial photograph of the same area shows the same widths as in 1936 but with dense urban development along the north bank. A 1962 aerial photograph of the same area shows a reduced canal width, no more than 200 feet, with dense urban development all the way to the edge of both banks.

Caño Martín Peña runs between Laguna San José, on the east, and the southeastern corner of San Juan Bay, on the west. Originally, Quebrada Juan Méndez emptied into its eastern end, as well (refer to Figure 3, Main Report). The channel is the line of demarcation between the San Juan wards called Santurce (on the north) and Hato Rey (on the south). Individual neighborhoods adjoining the channel are called, on the south side, beginning at Avenida Luís Muñoz Rivera and moving eastward, Parada 27, Las Monjas, Buena Vista (Hato Rey), Bitumul, Israel, and Sierra Maestra. On the north side of the channel, also from west to east, are the neighborhoods Marina, Barrio Obrero, Buena Vista (Santurce), and Cantera. The first bridge over the channel was built in 1784, over a ford in the location now occupied by the Ponce de León Avenue bridge. The channel was apparently of variable width and rather shallow. It was described in 1900 as 30 to 150 feet wide and 2 to 10 feet deep, with the banks covered by low mangrove bushes, and oysters growing on the tree roots (Evermann 1900). The earliest detailed aerial photography of San Juan, dating from 1936, is reproduced as Figure 3 in the Main Report. The photo shows only marshes and shrubs bordering the channel on the south, while small shacks, evidently accessed via unpaved roads or boardwalks, extend nearly to the channel on the northwest, in Barrio Obrero. In 1946 the channel was much wider than reported in historic documents, ranging from 200 to 400 feet, and it must have been used for navigation. Interestingly, this photo does not show tall mangroves lining the channel. It appears that at the time, the bushes were kept constantly pruned for firewood, or regularly cut for charcoal.
